# **Selected Images of the Effects of the October 15, 2006, Kīholo Bay-Māhukona, Hawai‘i, Earthquakes and Recovery Efforts**

Data Series 506

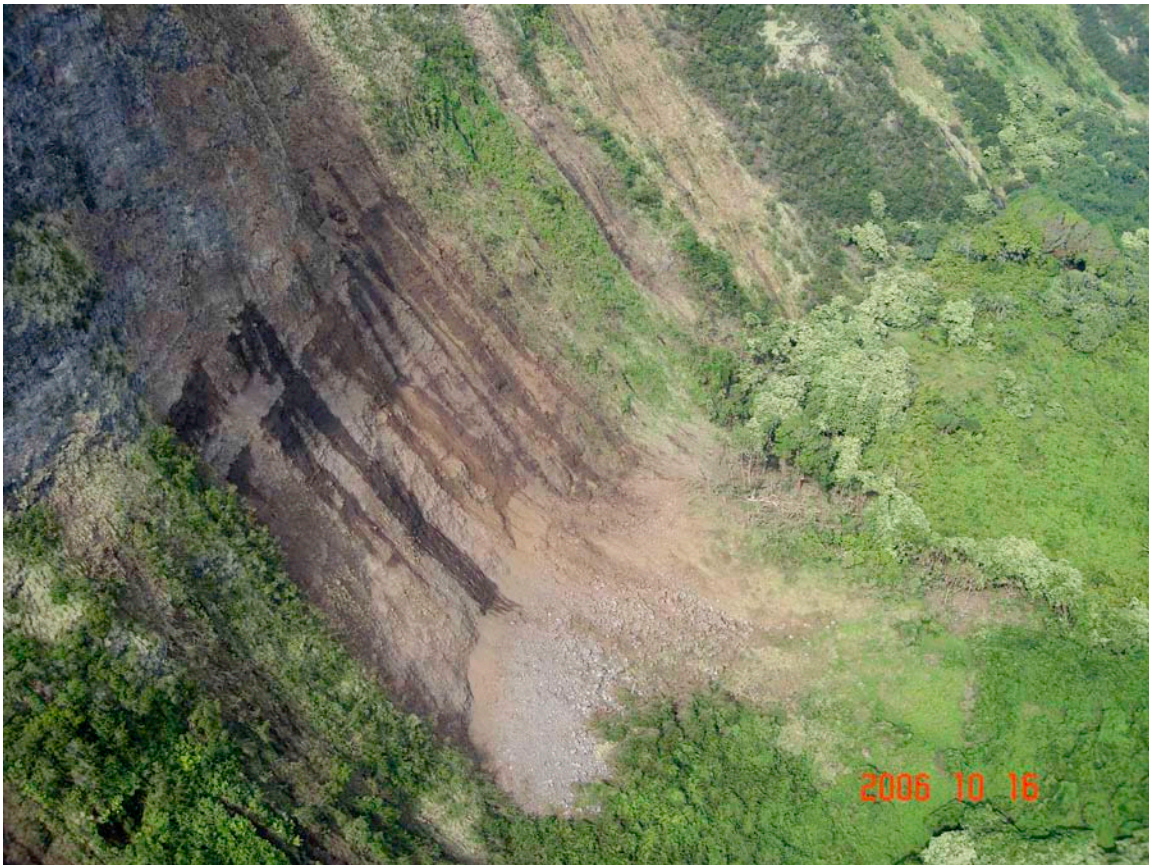
13.4. Near-vertical aerial view of rock-fall debris and groundwater seeps near the base of the sea cliff at Laupāhoehoe Nui (view to the west). DLNR photo by S. Bergfeld, 10/16/2006 (sb867).

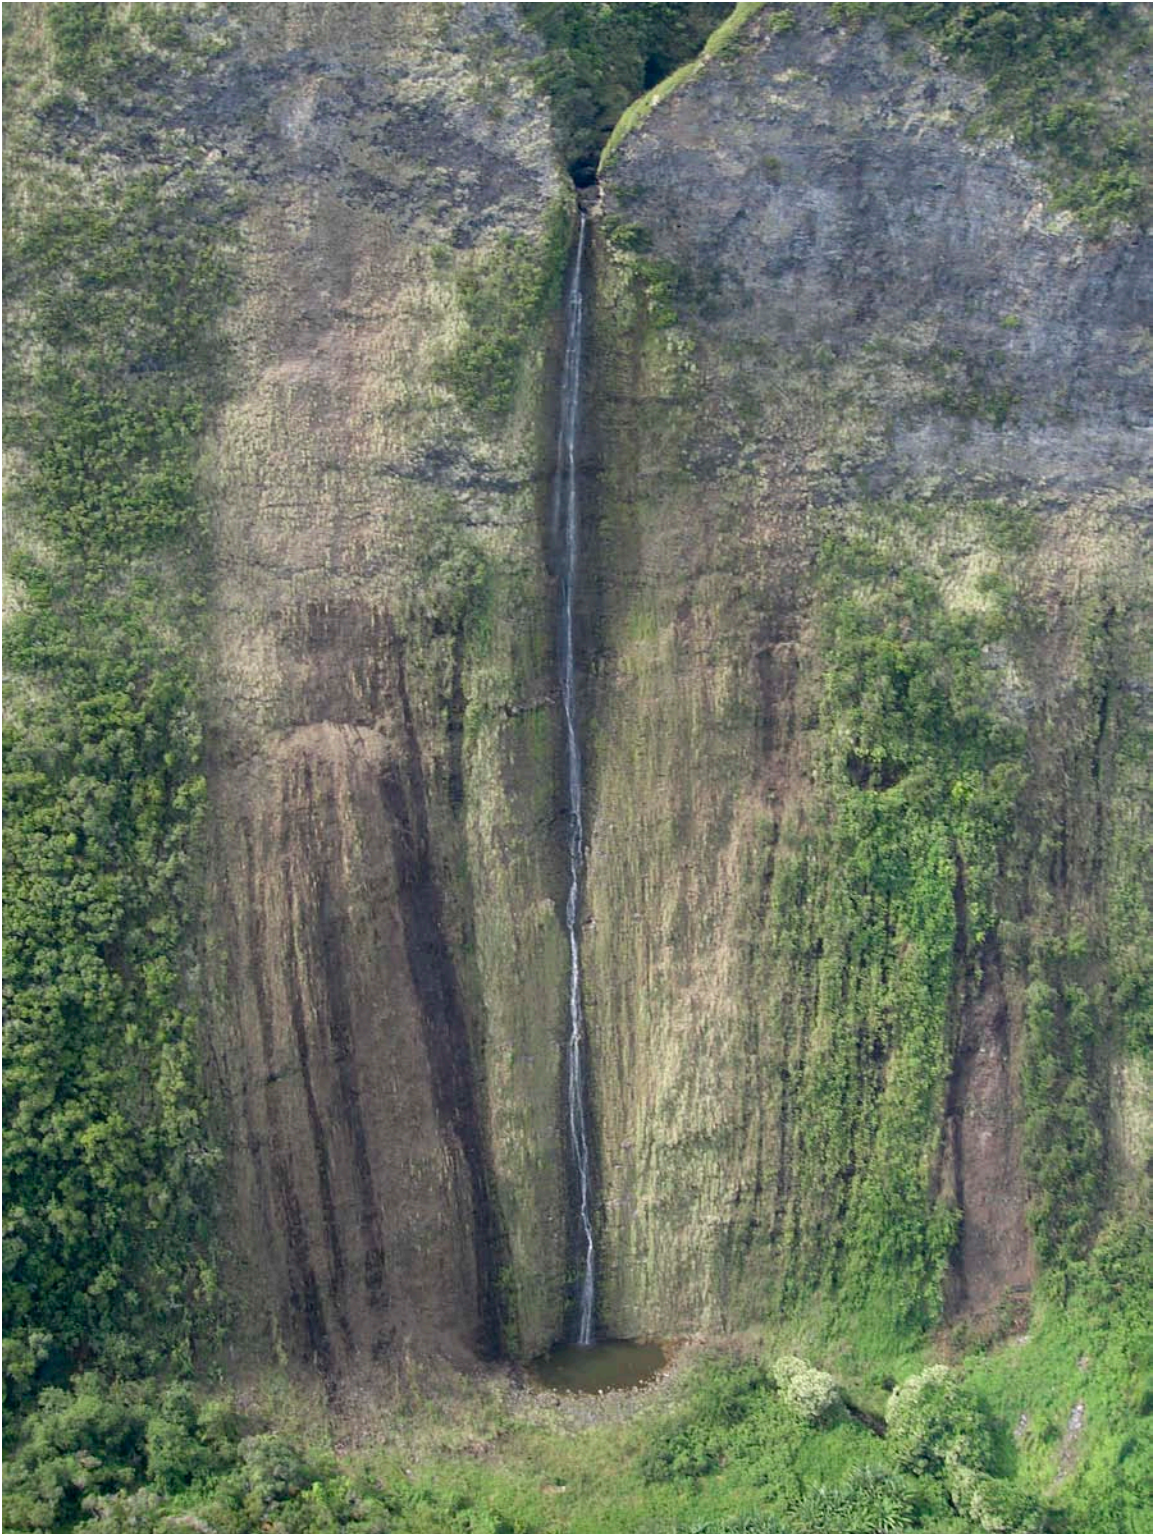
13.5. Aerial view of waterfall ending in a pool between sea cliffs scoured by rock falls at Laupāhoehoe Nui (view to the west). DLNR photo by S. Bergfeld, 10/16/2006 (sb866).

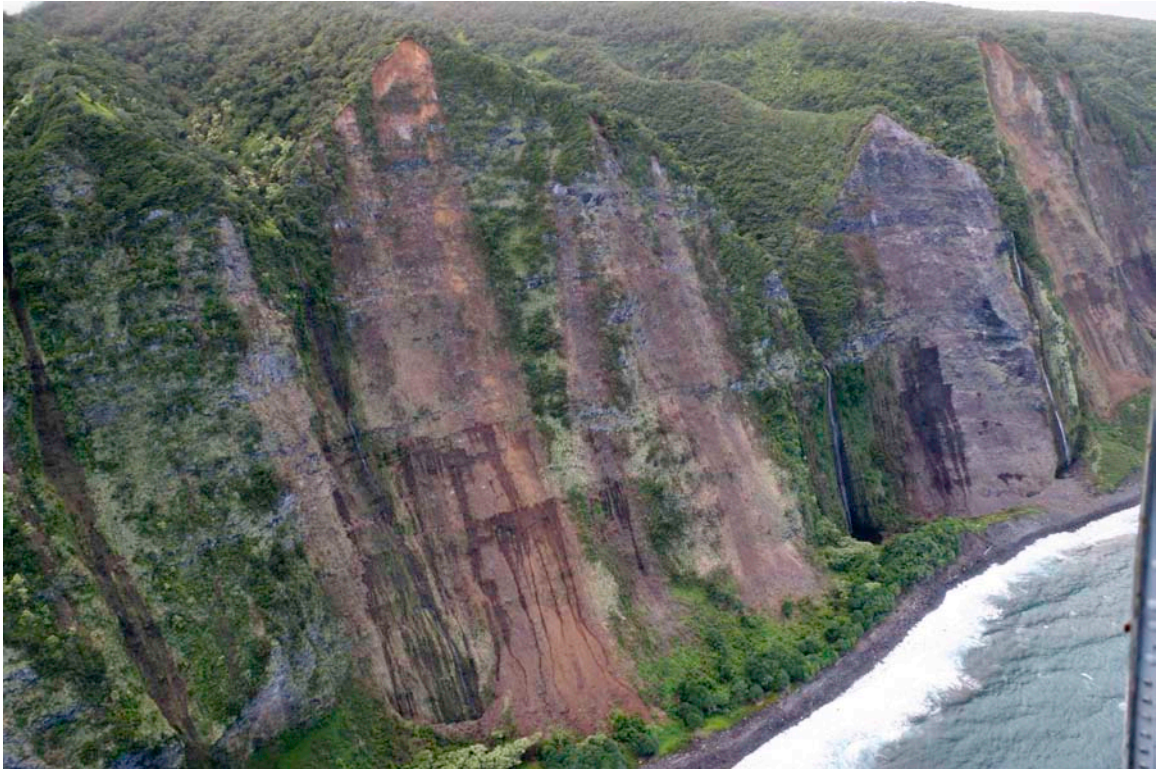
14.1. Aerial view of sea cliffs, crowned by dense vegetation and scoured by rock slides, north of Laupāhoehoe Nui. Note the two levels of groundwater seeps (darker-colored drip lines) across the cliff faces (view to the northwest). USGS photo by E.L. Harp, 11/8/2006 (elh1192).

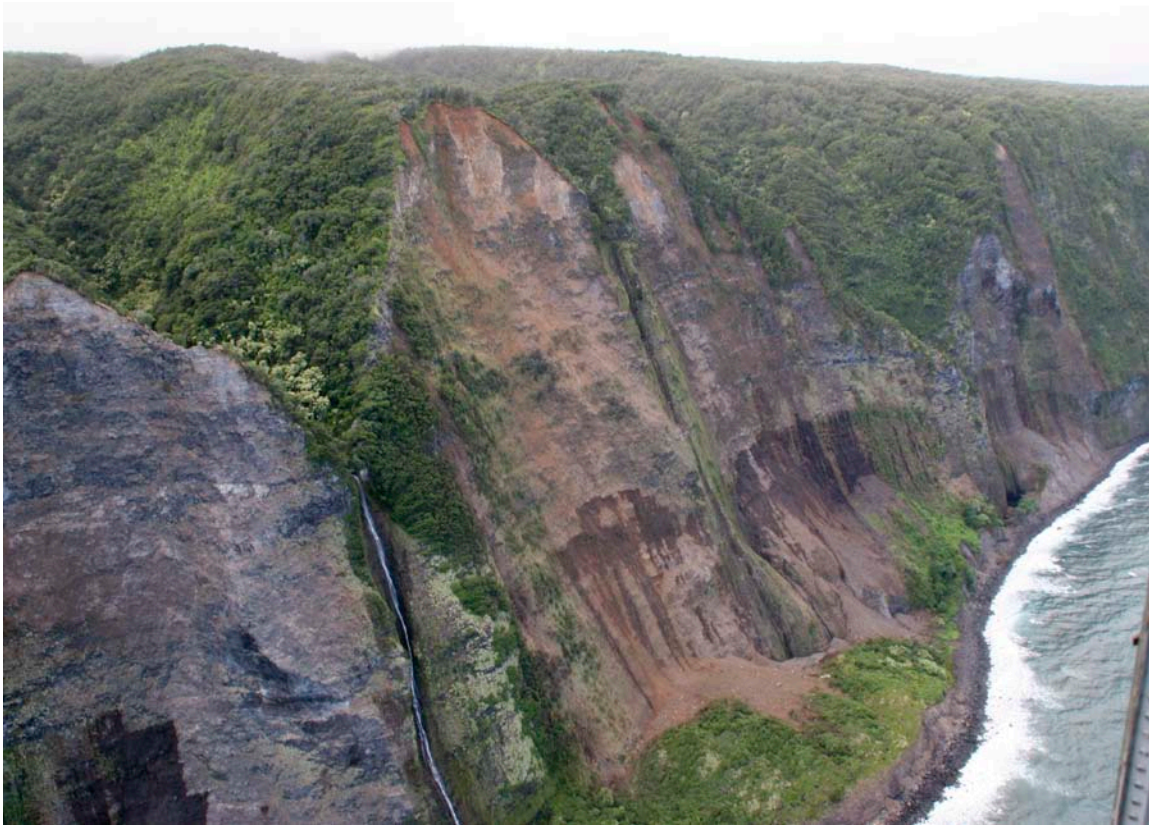
14.2. Aerial view of large rock and soil slides along sea cliffs north of Laupāhoehoe Nui. The Āpau debris fan lies at the base of the cliff, below the groundwater seeps in the foreground of the photo (view to the northwest). USGS photo by E.L. Harp, 11/8/2006 (elh1193).

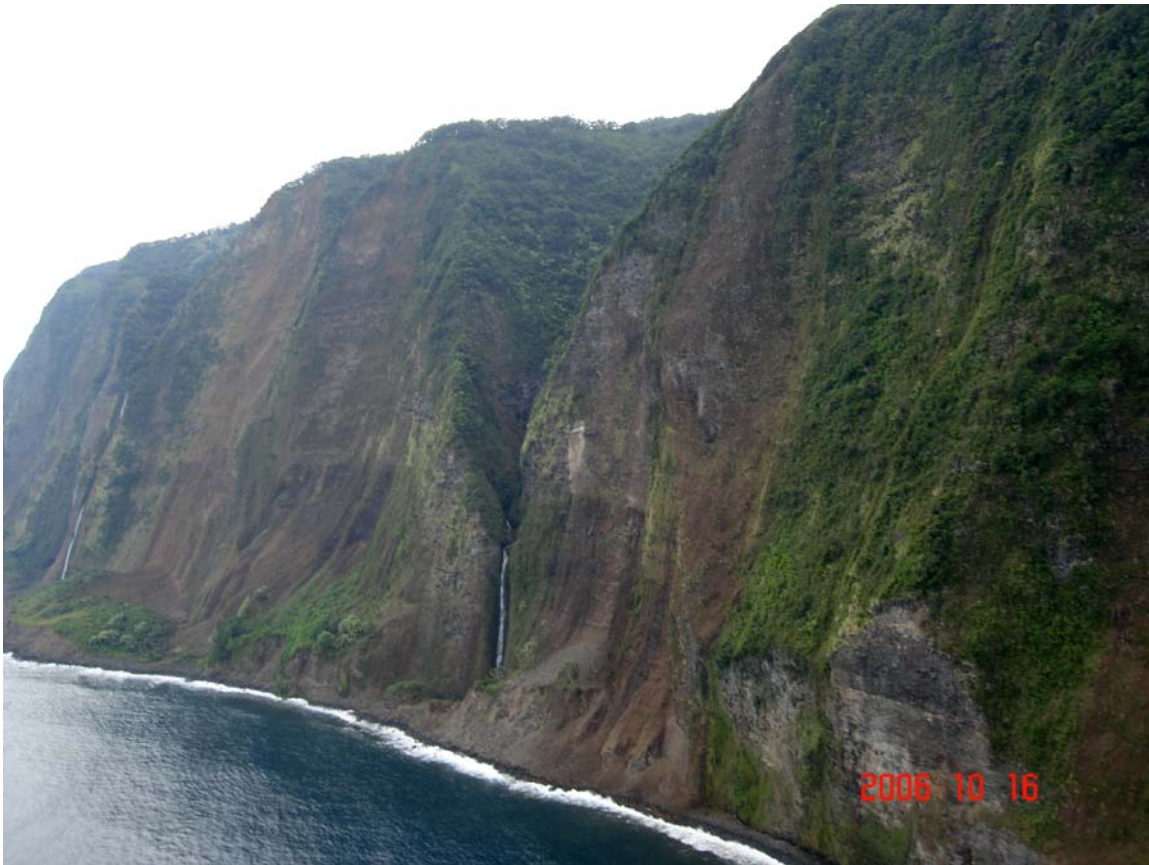
14.3. Aerial view of the sheared cliff, cleaved by a stream feeding a waterfall, flowing into the sea, near Honopue Valley. The Āpau debris fan lies between the two waterfalls (near the left edge of the photo; view to the southeast). DLNR photo by S. Bergfeld, 10/16/2006 (sb938).

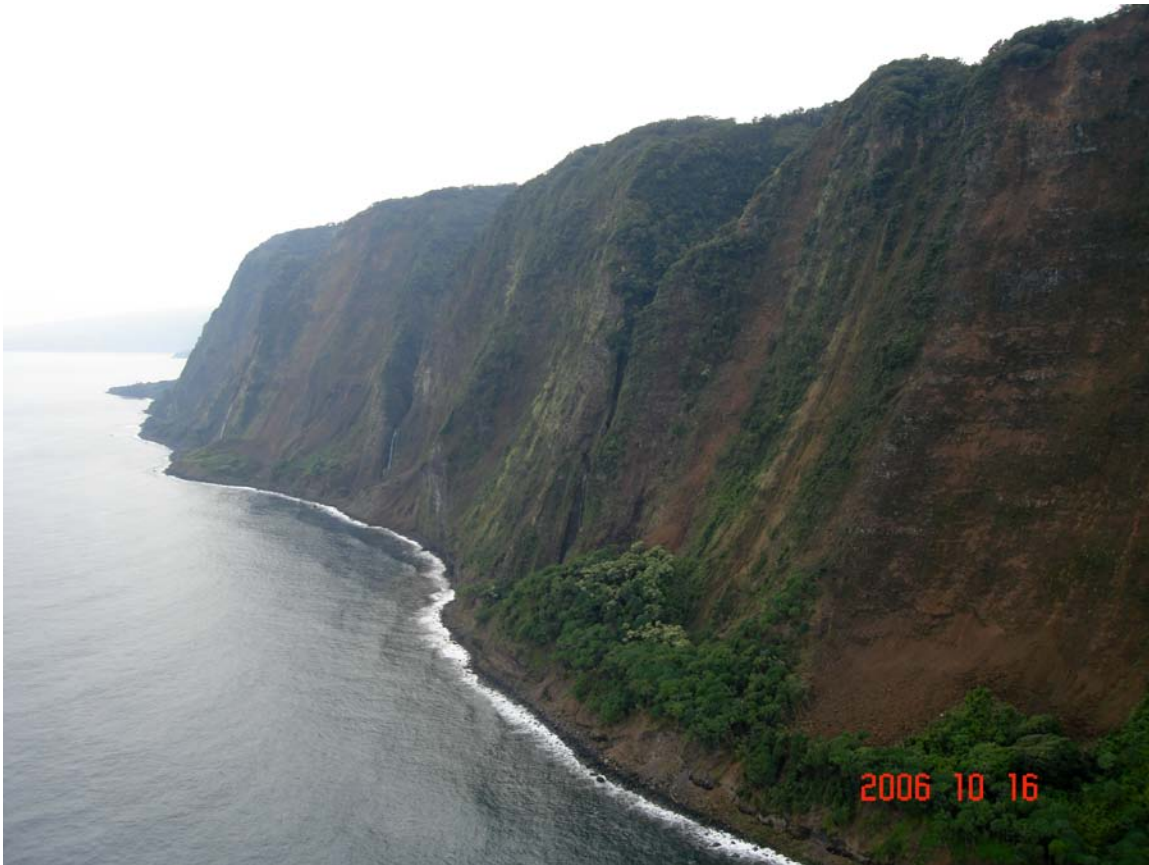
14.4. Aerial view of rock slides between Honopue Valley and the “toe” of Laupāhoehoe Nui in the distance. The Āpau debris fan lies between the two waterfalls (view to the southeast). DLNR photo by S. Bergfeld, 10/16/2006 (sb937).

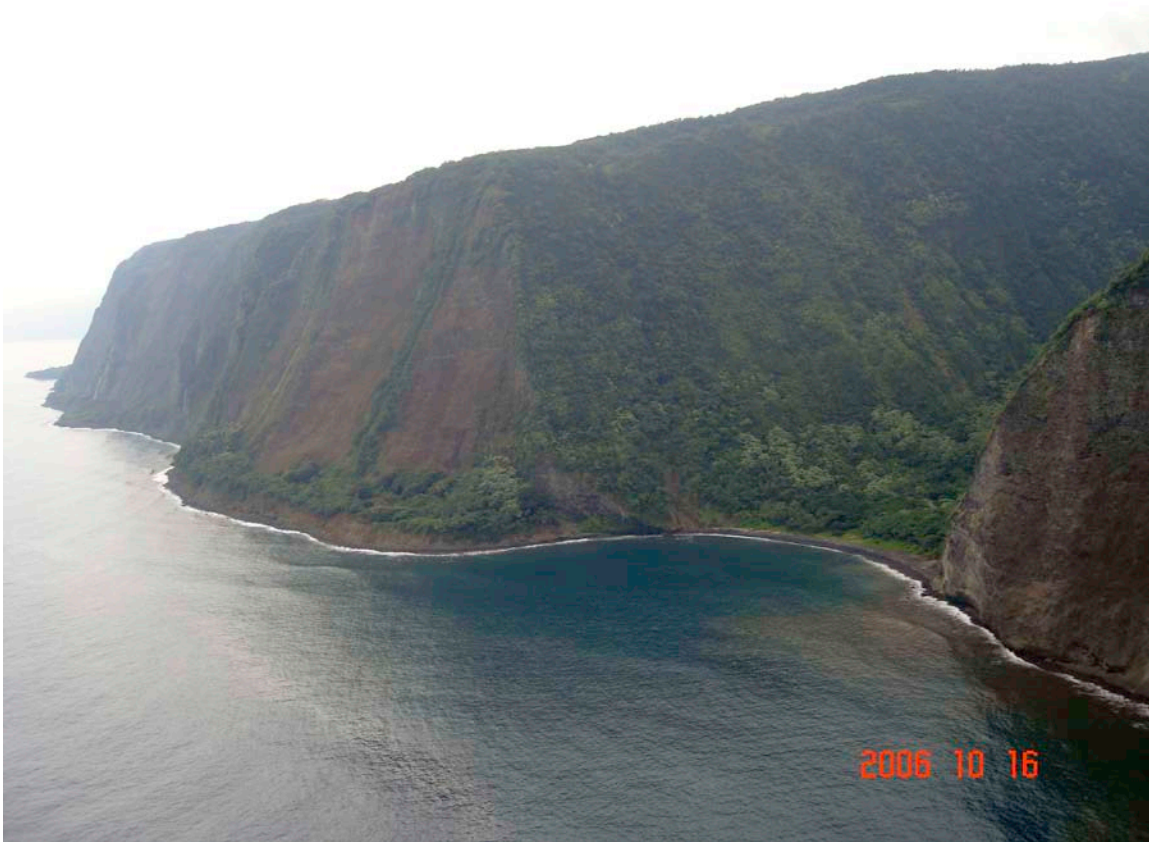
15.1. Aerial view of the abraded sea cliffs, with profiles of Laupāhoehoe Nui in the background and the Āpau debris fan between the two waterfalls. Traces of the sediment that rained down from the cliffs into the ocean are visible at the lower right of the photo (view to the southeast). DLNR photo by S. Bergfeld, 10/16/2006 (sb936).

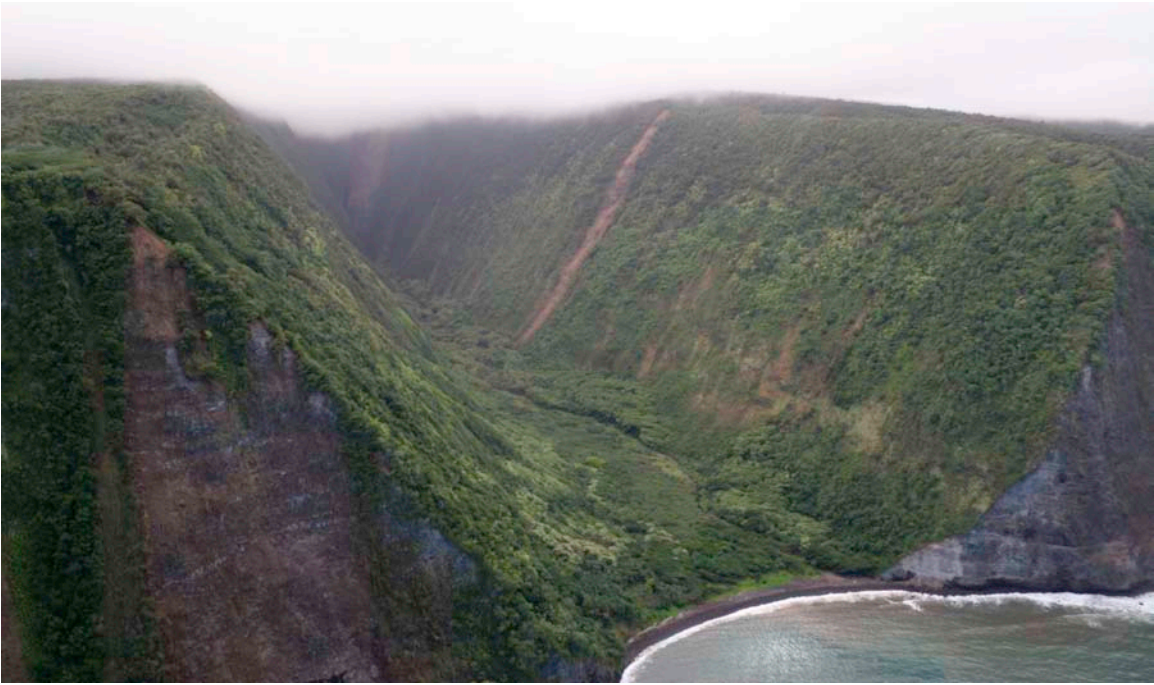
15.2. Aerial view of the mouth of northwest Honopue Valley. Aside from the dominant rock-fall scar, numerous slides scraped the western wall (view to the southwest). USGS photo by E.L. Harp, 11/8/2006 (elh1195).

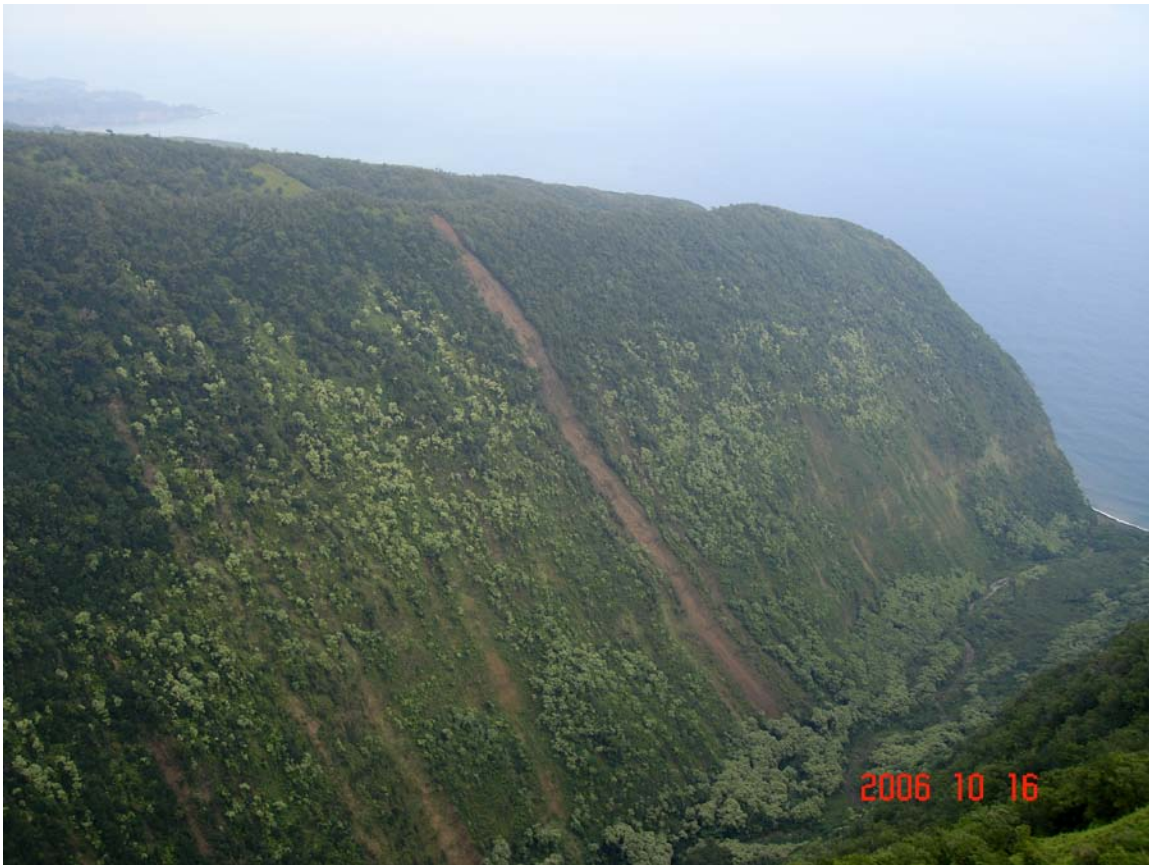
15.3. Aerial view of the long rock-fall scar in Honopue Valley. Other, smaller slides thinned out the dense vegetation covering the valley's western wall (view to the north). DLNR photo by S. Bergfeld, 10/16/2006 (sb873).

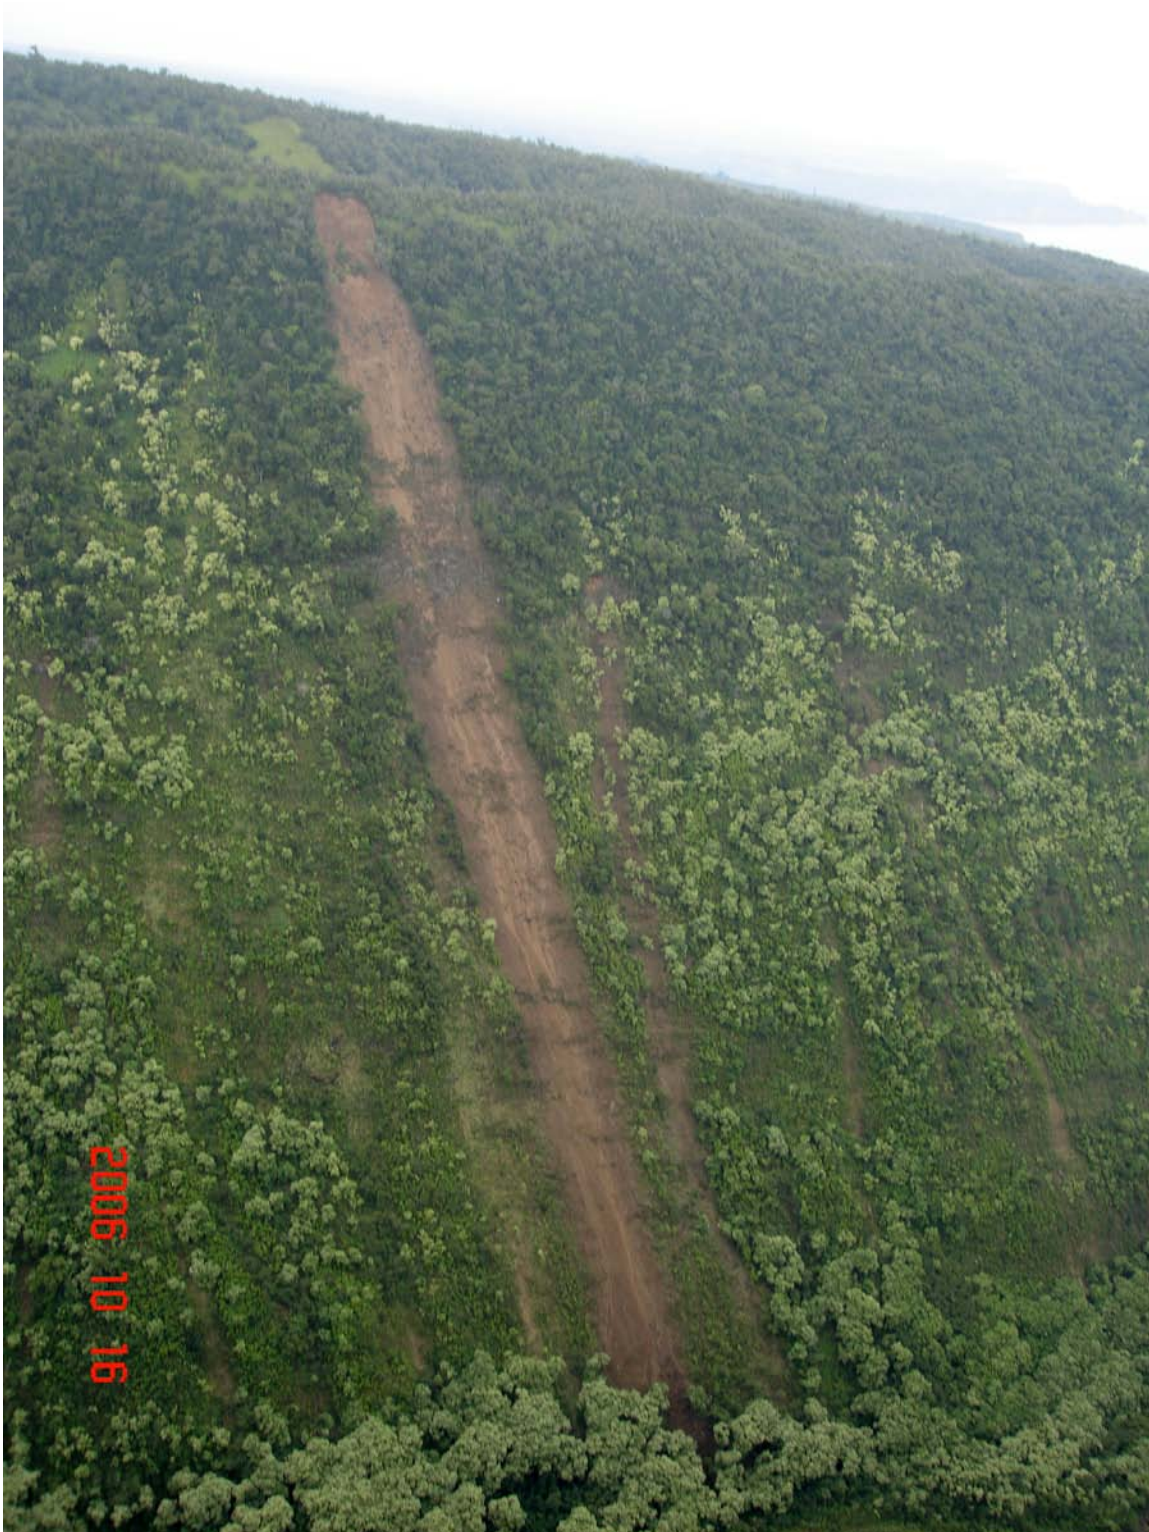
15.4. Close-up aerial view of the rock fall that peeled away the thick growth on the west wall of Honopue Valley (view to the west). DLNR photo by S. Bergfeld, 10/16/2006 (sb940).

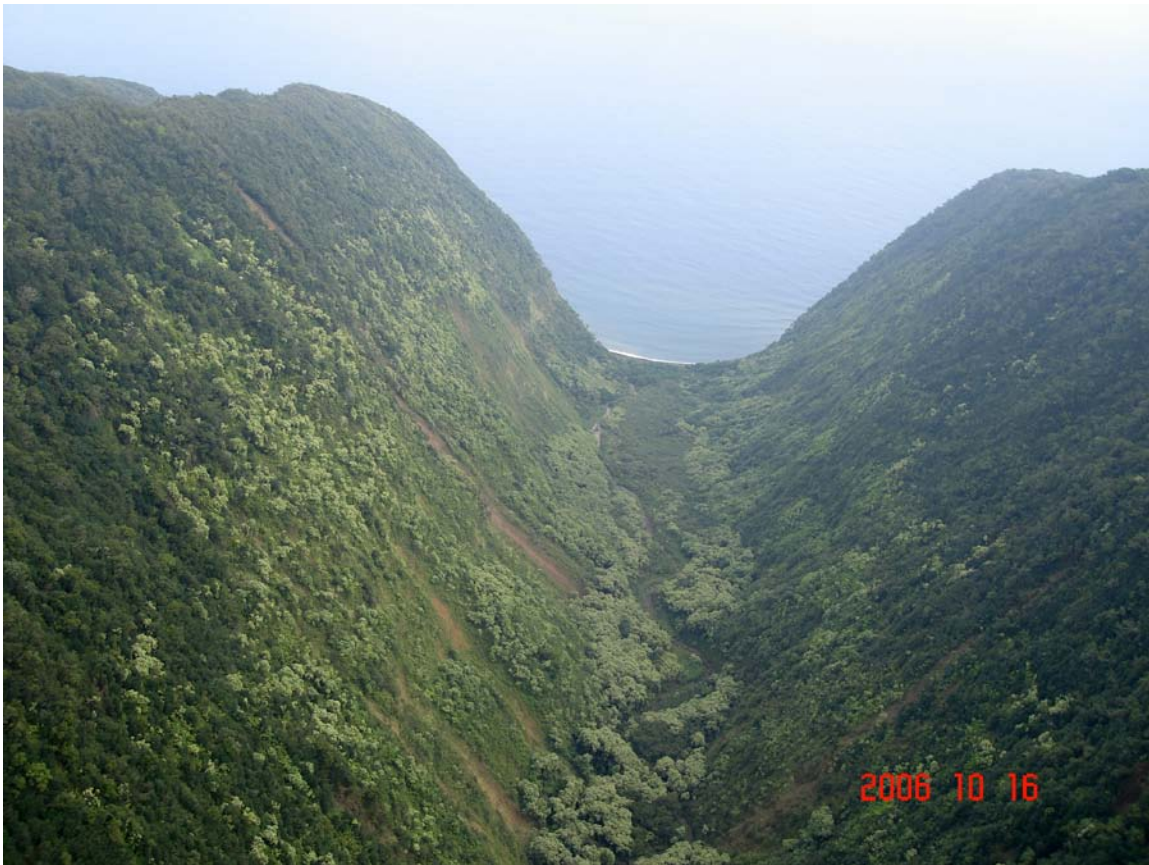
15.5. Aerial overview, looking out to sea, of the heavily forested valley floor and rock and soil slides along the western walls of Honopue Valley. Untrammed by animals or human habitation, the valley floor and much of its walls are covered with a dense growth of kukui (candlenut) trees, distinguished by their light-green canopy (view to the north-northeast). DLNR photo by S. Bergfeld, 10/16/2006 (sb878).

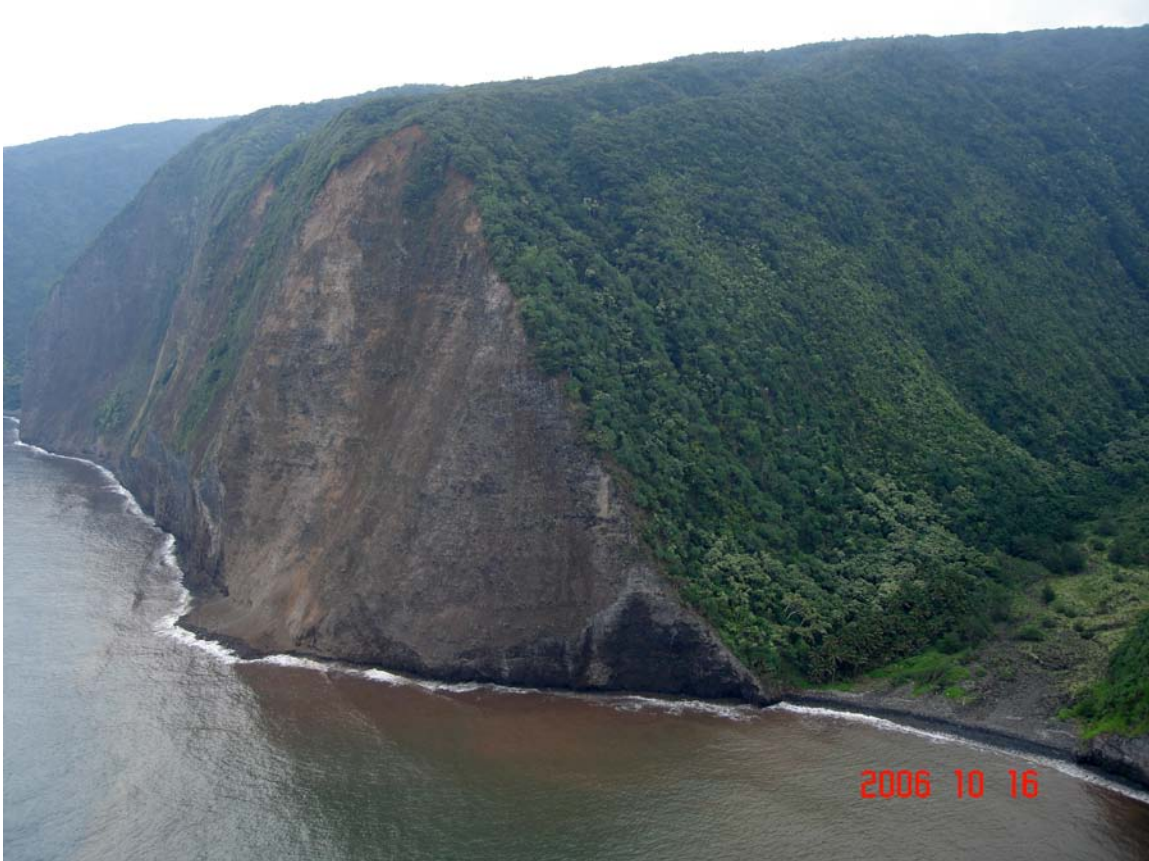
16.1. Aerial view of the barren sea cliff, rock-fall deposit, and seawater muddy from runoff at the entrance to Honoke‘ā Valley (view to the southeast, toward Honopue Valley, the indentation at the left edge of the photo). DLNR photo by S. Bergfeld, 10/16/2006 (sb934).

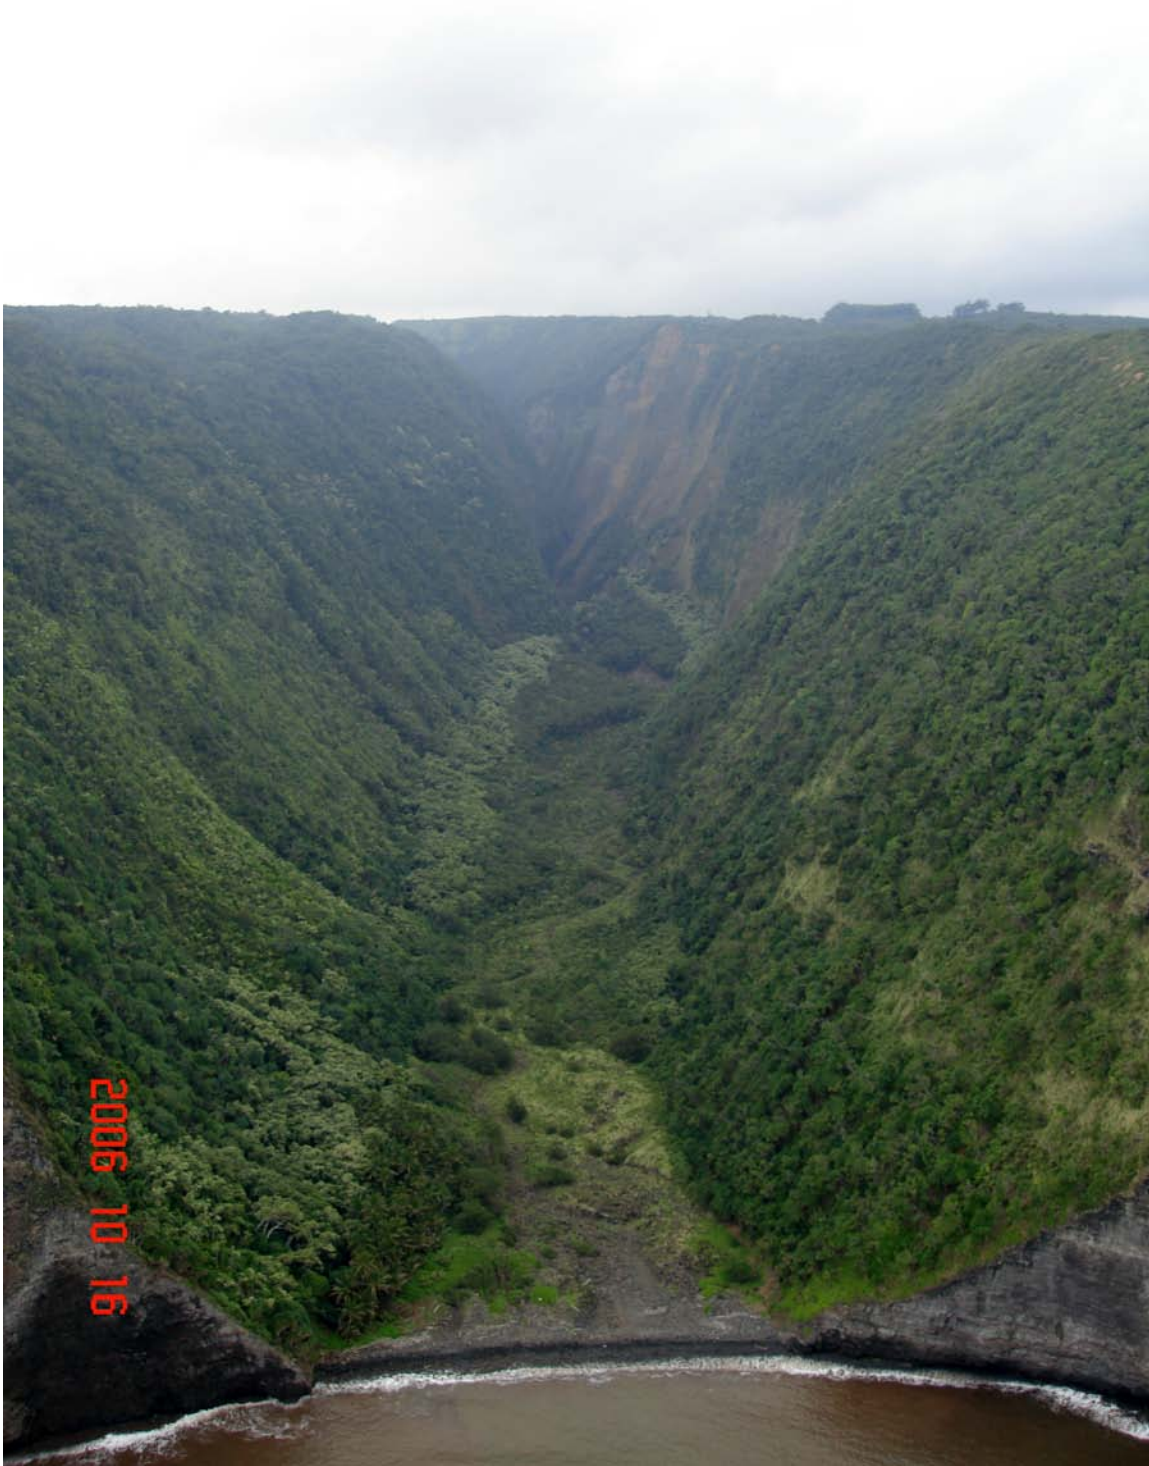
16.2. Aerial view of the heavily forested floor and walls of Honoke‘ā Valley. Massive rock falls along the upper western valley walls are visible in the distance (view to the southwest). DLNR photo by S. Bergfeld, 10/16/2006 (sb935).

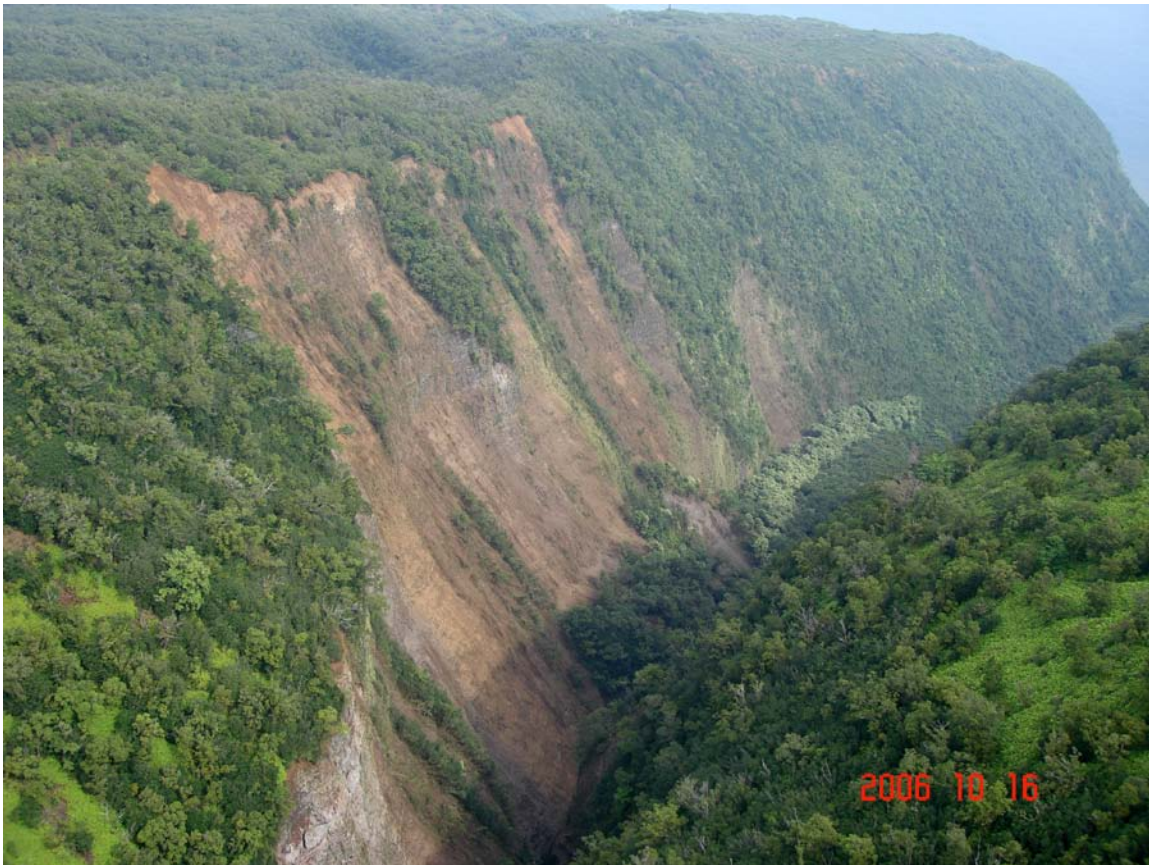
16.3. Close-up aerial view of extensive deforestation by rock falls along the western cliffs of Honokeʻā Valley (view to the north). DLNR photo by S. Bergfeld, 10/16/2006 (sb880).

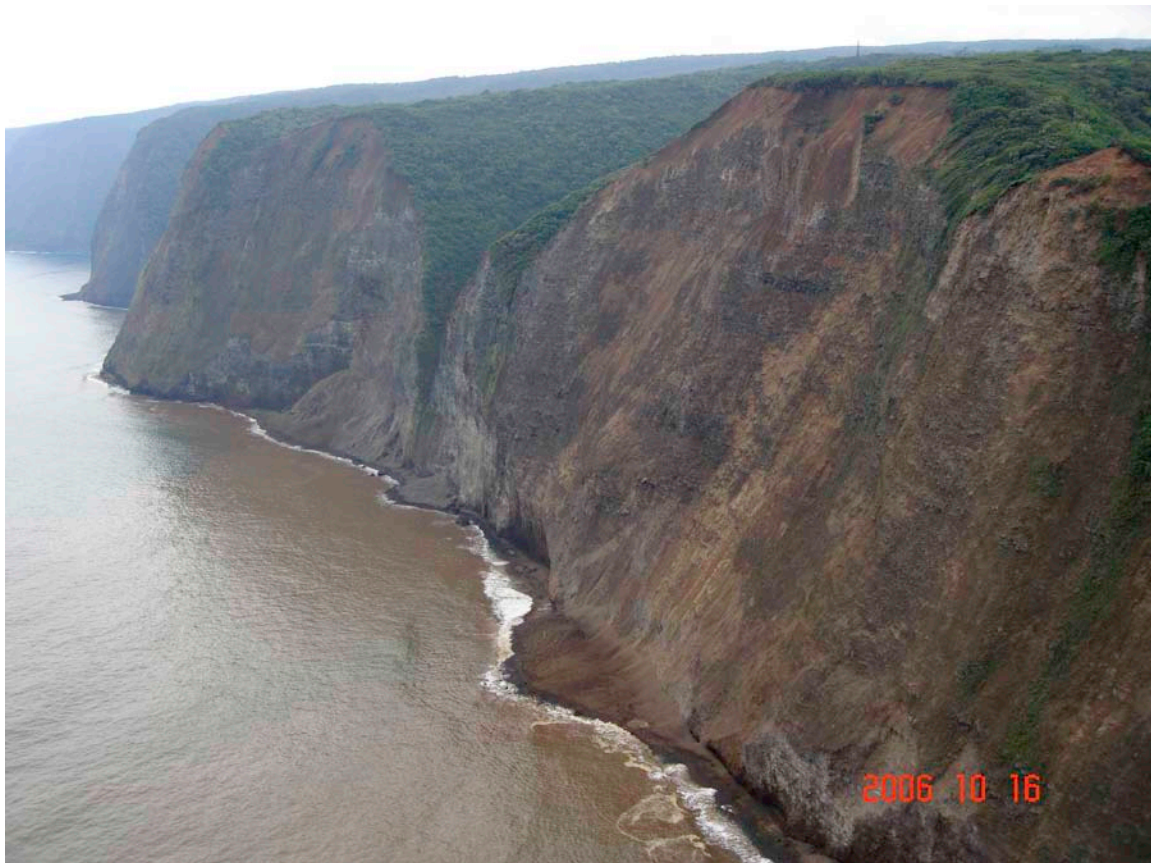
17.1. Aerial view of the rock and soil debris that laid waste the cliffs along the Hāmākua and North Kohala coasts (the fresh deposits yet to be washed away from the base of the cliffs)—from the entrance of Honokāne Iki Valley, southeast along the coast, toward Honoke‘ā Valley, and beyond, to the entrance of Honopue Valley. Waipahi Stream flows into the sea at the deep cleft, mantled by vegetation (view to the southeast). DLNR photo by S. Bergfeld, 10/16/2006 (sb933).

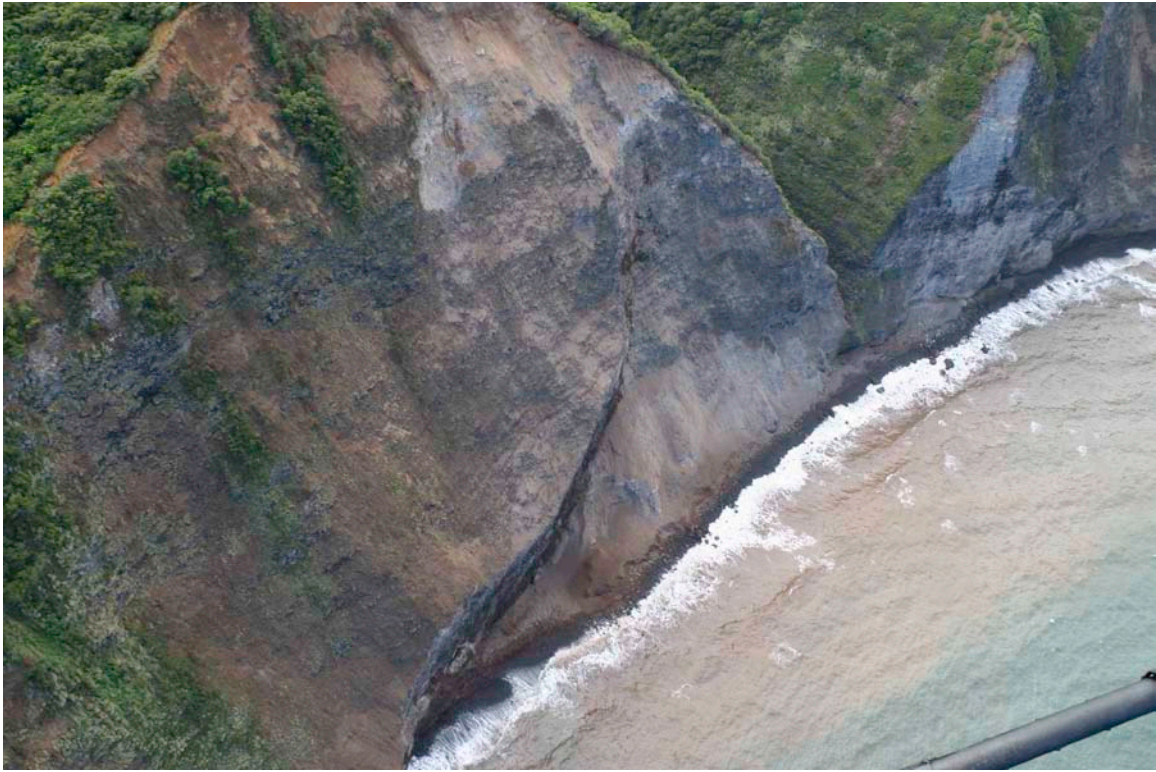
17.2. Close-up aerial view of sea cliffs, scoured by rock falls, between Honoke‘ā and Honokāne Iki valleys. Waipahi Stream empties into the ocean between sea cliffs, where seawater is muddy from rock falls and runoff (view to the southwest). USGS photo by E.L. Harp, 11/8/2006 (elh1200).

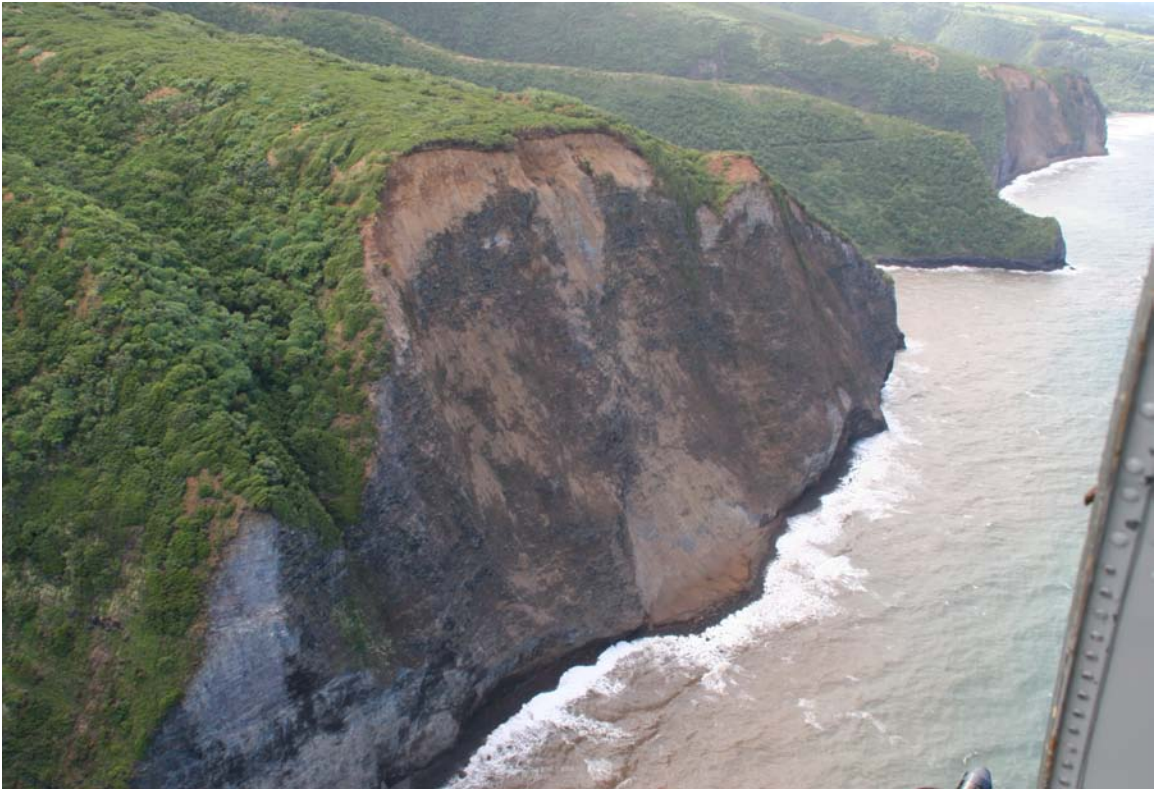
17.3. Aerial view of eroded sea cliffs, with a fresh rock-fall deposit at its base, between Waipahi Stream and Honokāne Iki Valley, North Kohala coast. Honokāne Iki Valley is hidden behind the foreground sea cliff and Honokāne Nui Valley, tucked behind the ridge (outlined by the 'Āwini Trail), whose truncated promontory juts out into the sea. In the far distance (top right of photo), the scoured coastal cliff face, with bald spots in its crown, conceals Pololū Valley from view (view to the southwest). USGS photo by E.L. Harp, 11/8/2006 (elh1201).

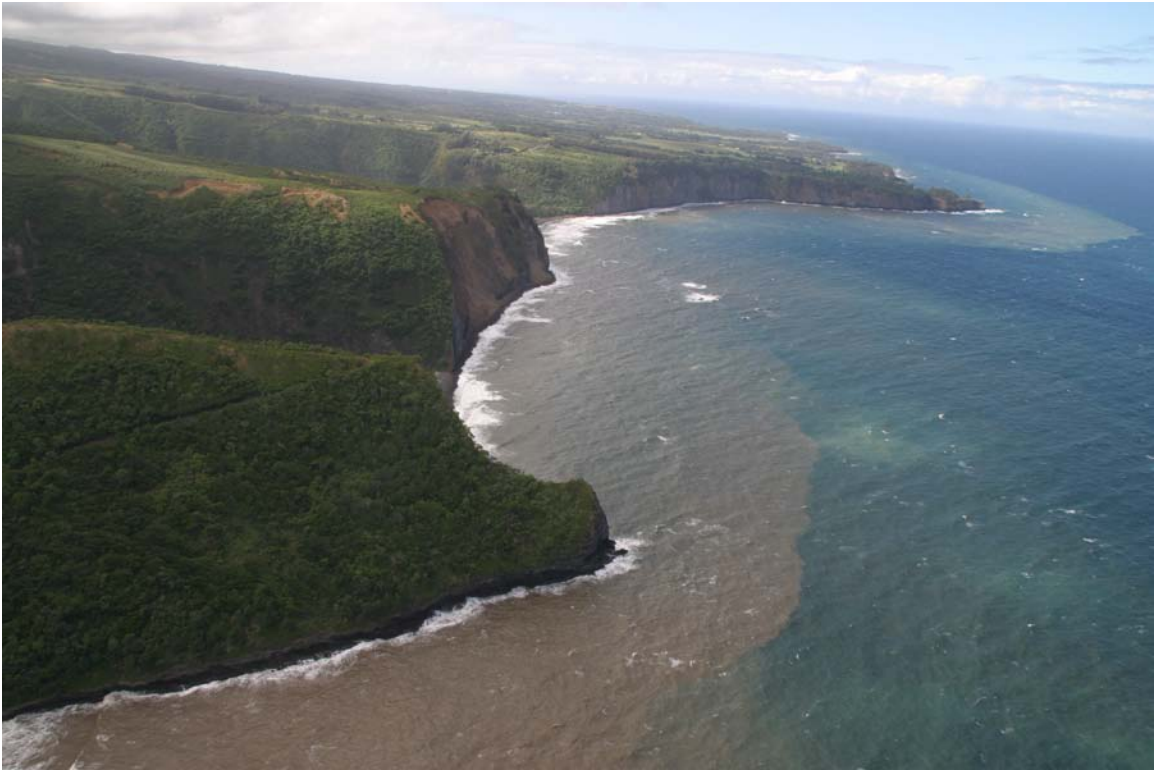
17.4. Aerial view of the North Kohala coastline, from the mouth of Honokāne Valley in the foreground to ‘Āko‘ako‘a Point (upper right of photo) in the background. Honokāne Nui Valley is hidden behind the ridge (with the ‘Āwini Trail), terminating at the blunt end of the point in the foreground. Pololū Valley is concealed behind the raw sea cliff and damaged crown, and ‘Āko‘ako‘a Point ends the long coastline facing the viewer. Sediment from runoffs muddied the ocean following several days of heavy rainstorms after the earthquake (FEMA, 2006) (view to the northwest). USGS photo by R.W. Jibson, 11/8/2006 (rwj143).

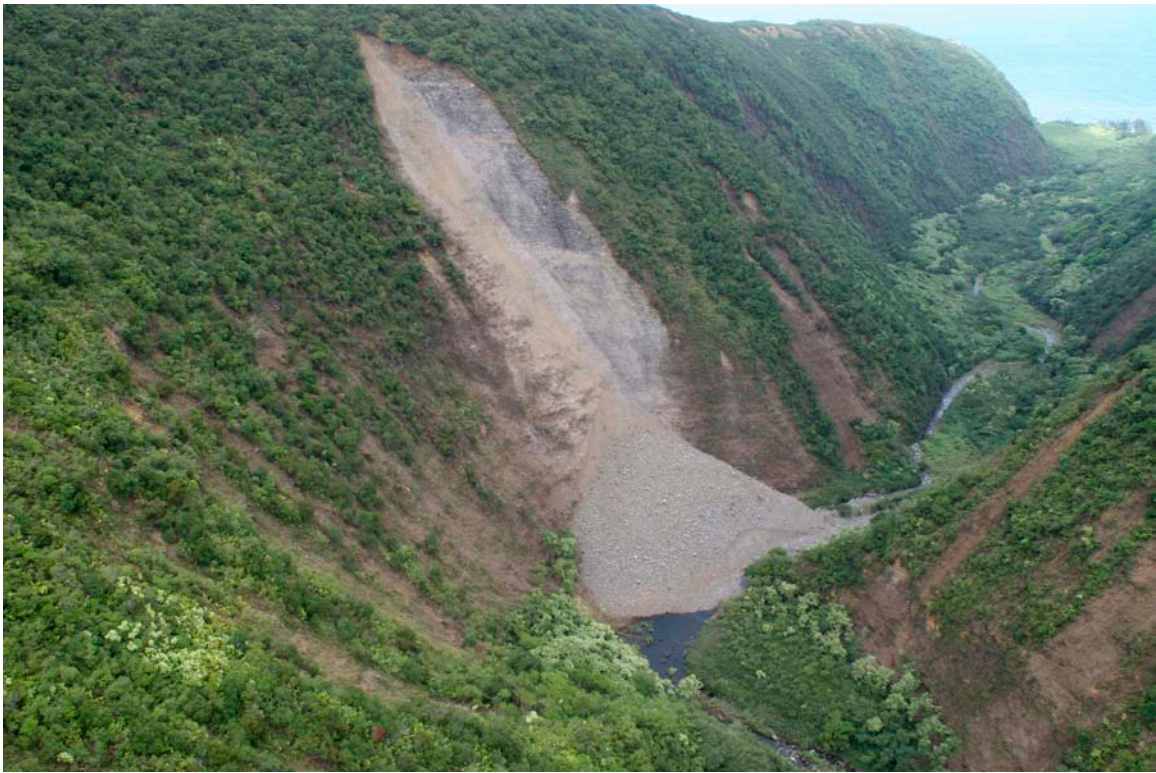
18.1. Aerial view of the massive rock slide whose debris diverted the course of Honokāne Nui Stream (view to the north-northwest). USGS photo by E.L. Harp, 11/8/2006 (elh1205).

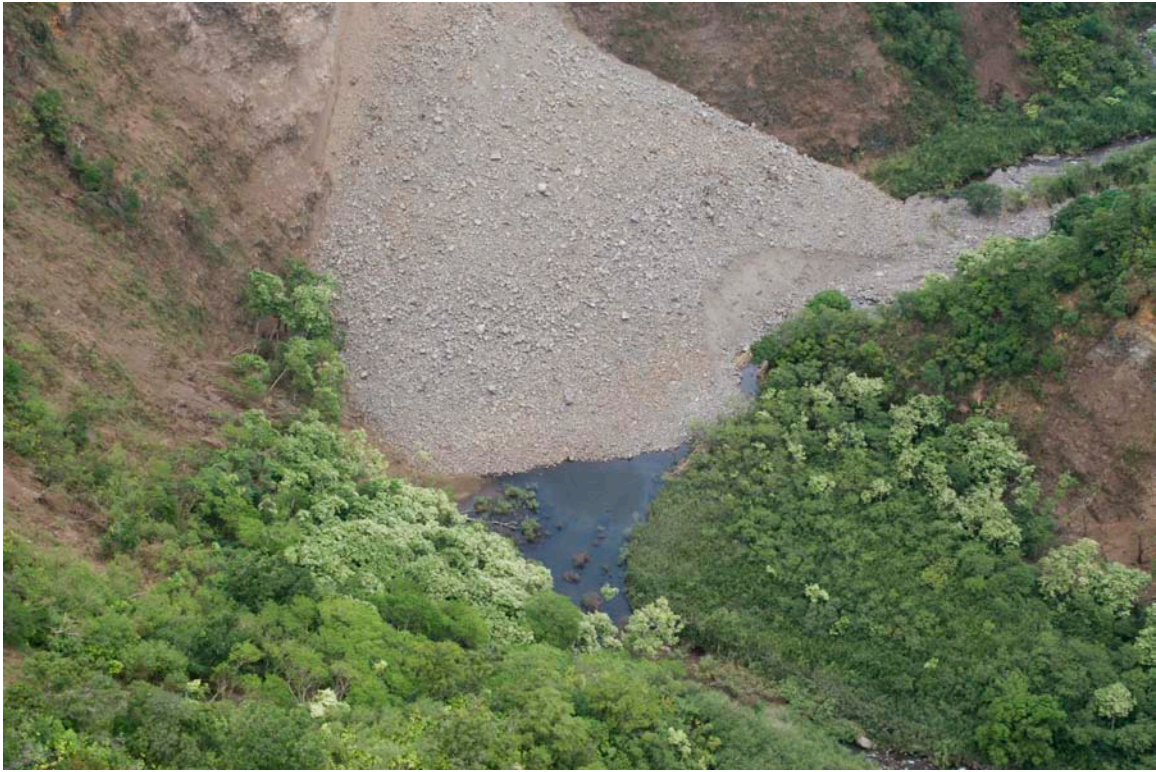
18.2. Close-up aerial view of the talus deposit from the large rock slide that diverted the stream in Honokāne Nui Valley (view to the north-northwest). USGS photo by E.L. Harp, 11/8/2006 (elh1204).
